Fractography of Advanced Structural Ceramics: Results From The VAMAS Round Robin Exercise

Jeffrey J. Swab and George Quinn

ARL-TR-656

December 1994

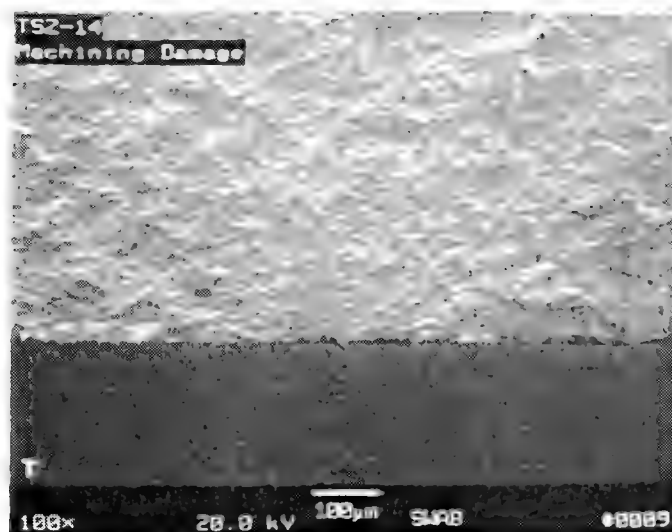
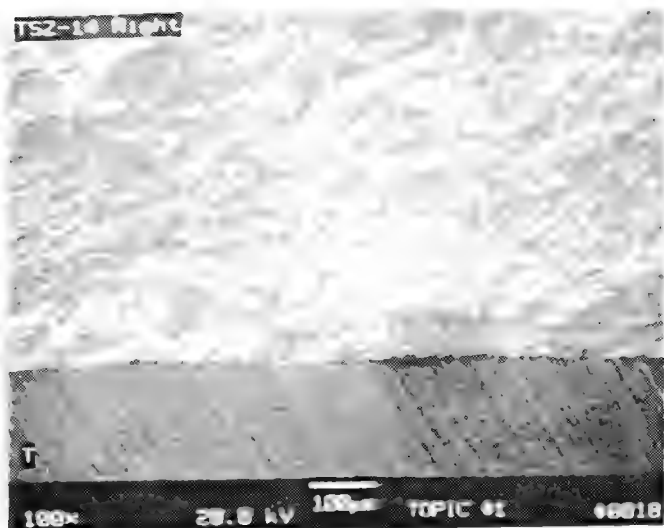
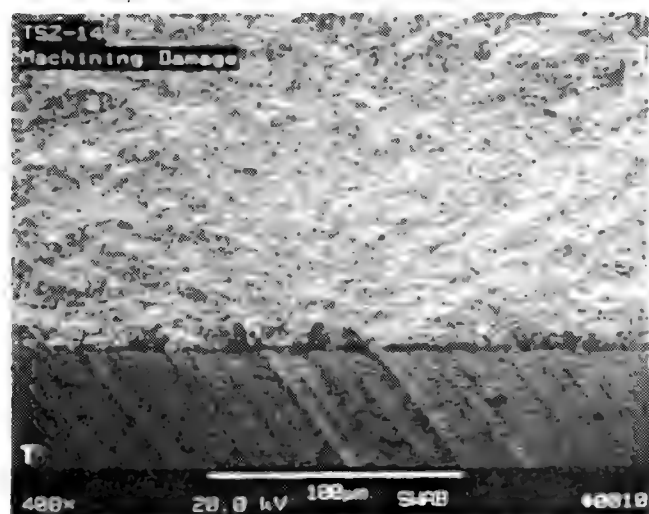
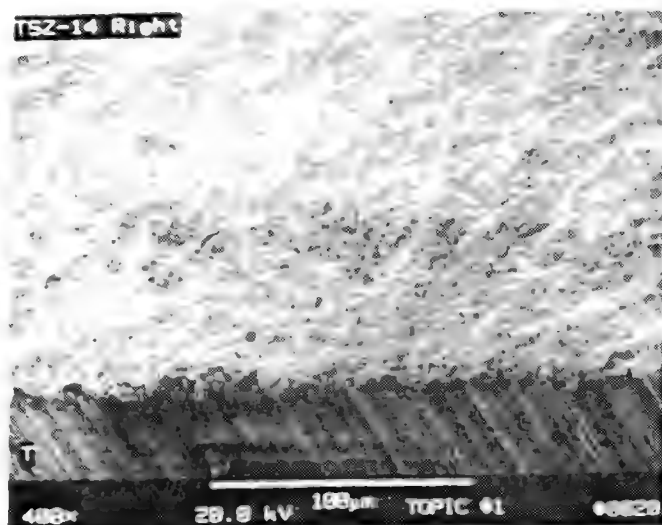
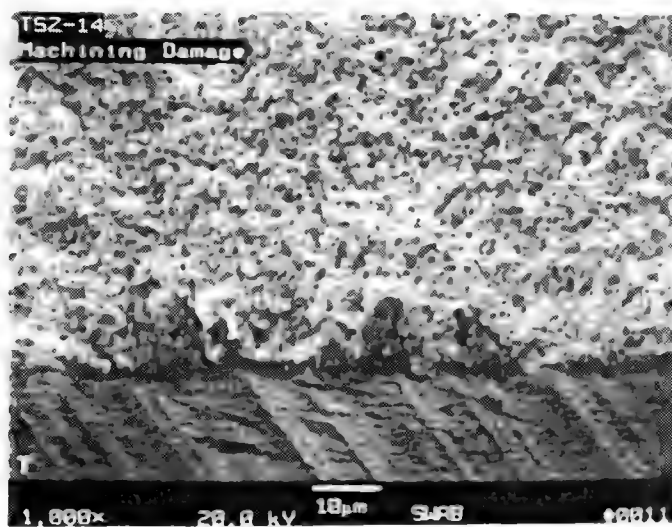
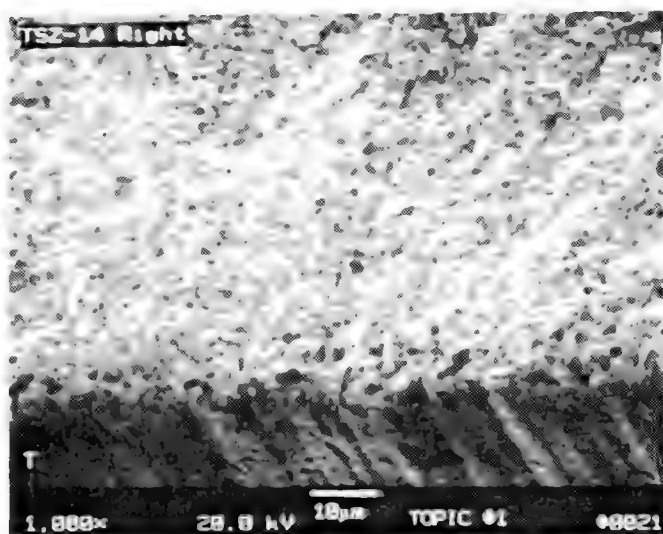
Figure 1.2. The three pairs of photographs for Set #1 (TSZ-14) which were provided to the participants. "T" denotes the tensile surface.

PARTICIPANTS' RESULTS - LOCATION IN ZIRCONIA/ALUMINA - The consensus was that the origin was located at the surface. However, one participant believed the origin was close to but not at the surface (thus the near surface label) while another established the origin as being located at an edge.

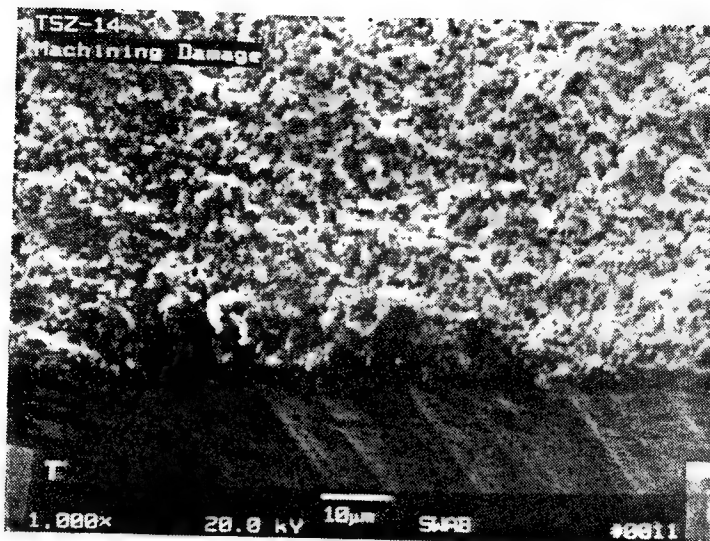
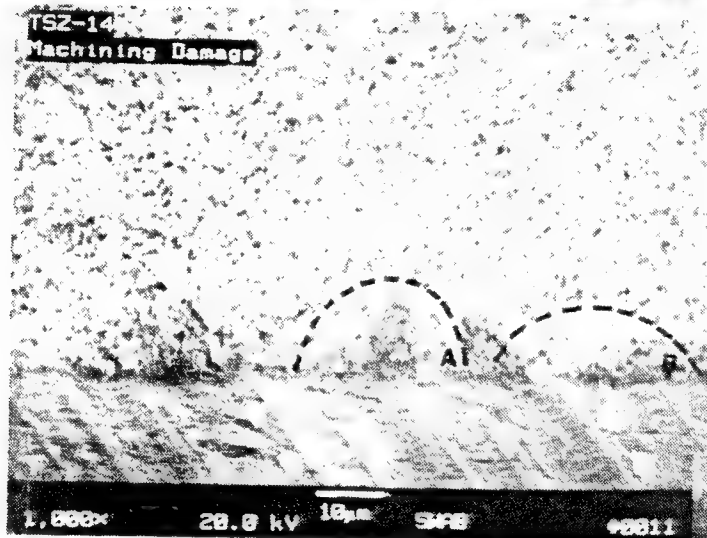
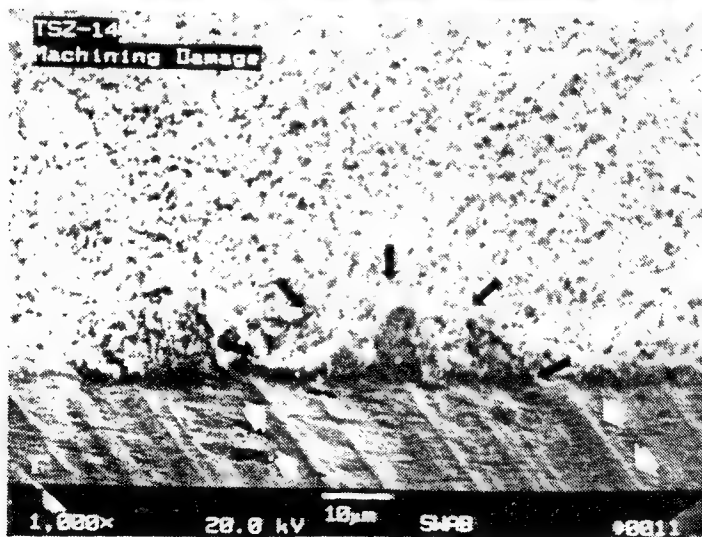
Figure 1.3. High magnification photographs of one half of the fracture surface from Set #1 (TSZ-14). A) Unmarked. B) The organizers outlined two possible semicircular origins. Arrows indicate possible striations on tensile surface. C) The organizers outlined a possible semielliptical origin. "T" denotes the tensile surface.

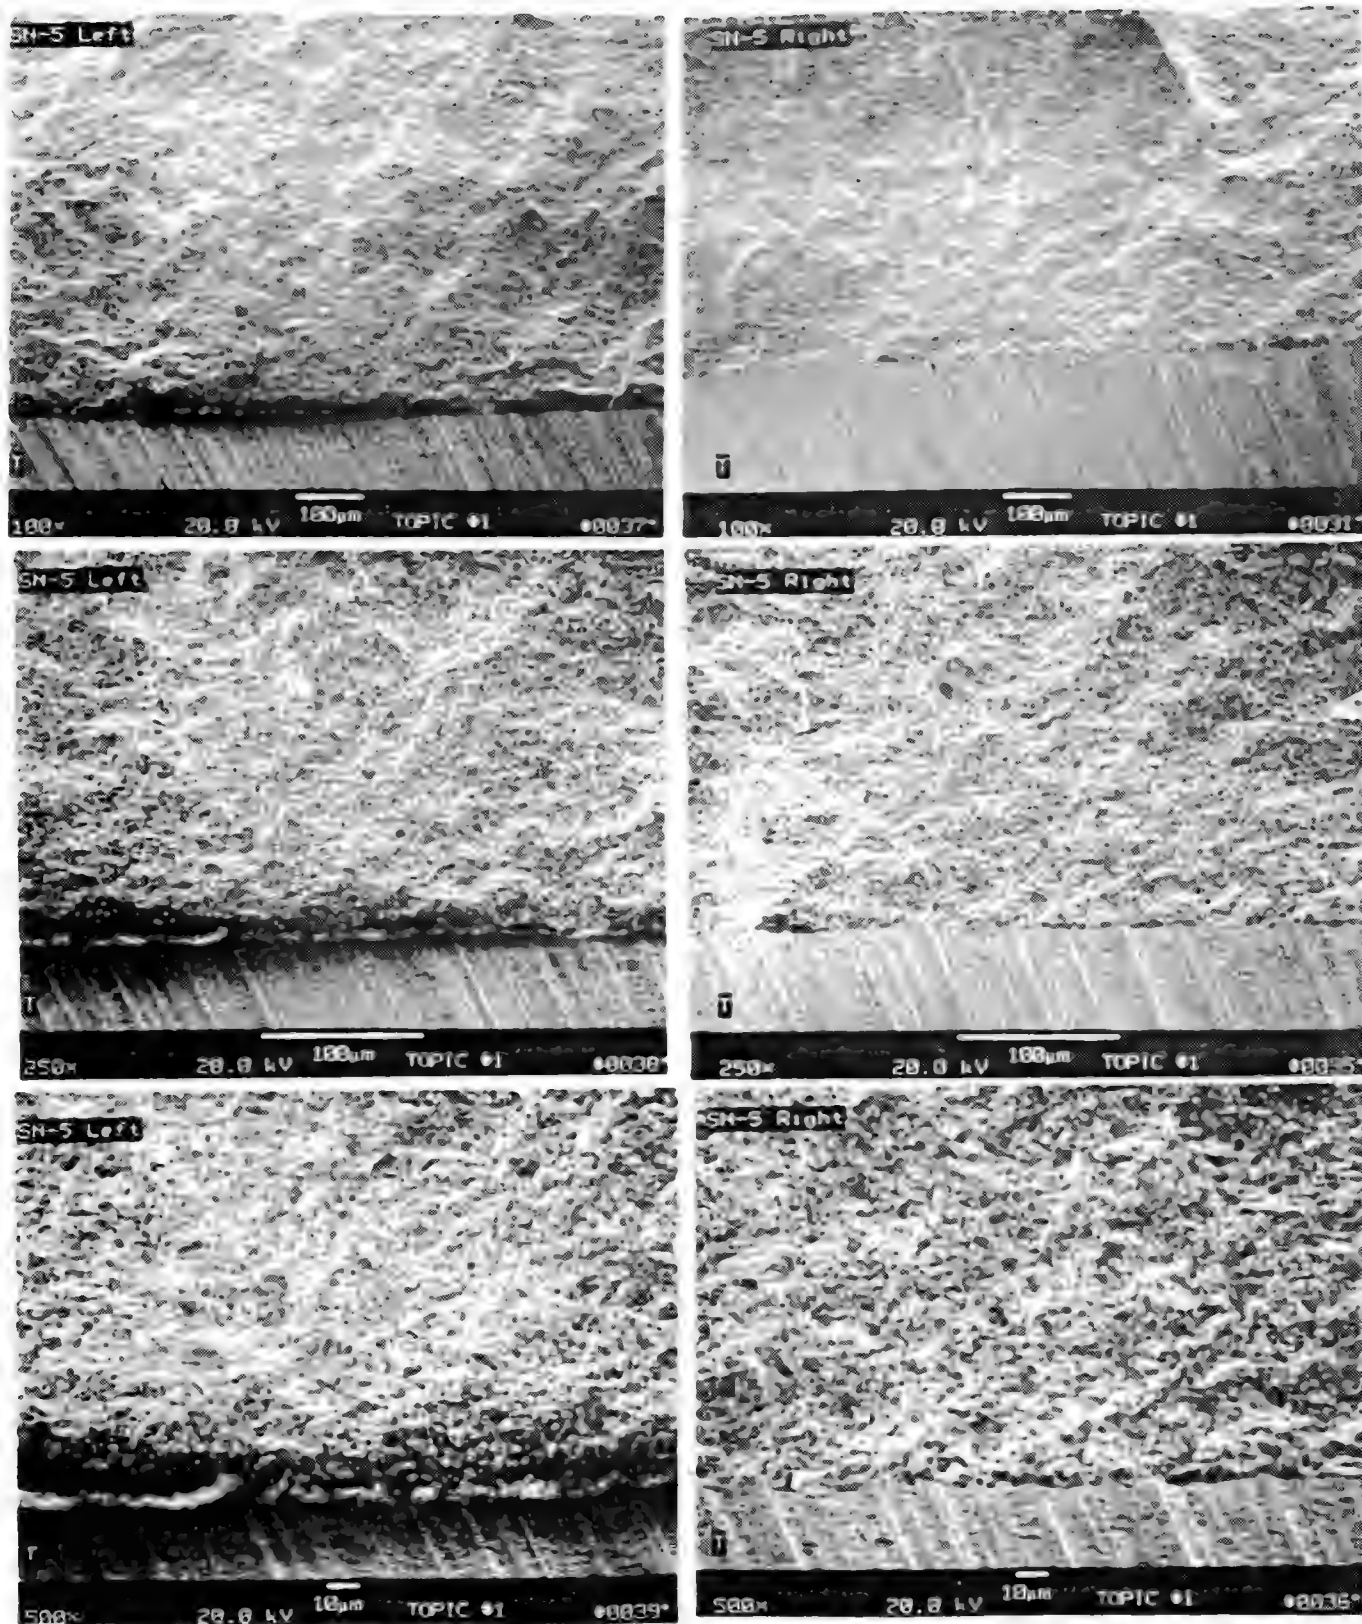
Figure 1.4. The three pairs of photographs for Set #2 (SN-5) which were provided to the participants. "T" denotes the tensile surface.

PARTICIPANTS' RESULTS - *LOCATION IN SILICON NITRIDE* - The consensus was that the origin was located at the surface, however, there were three participants who felt the origin was located elsewhere. One felt it was located "at the edge", one thought it was "near-to-the-surface", while the third was not sure if it was surface or near surface.

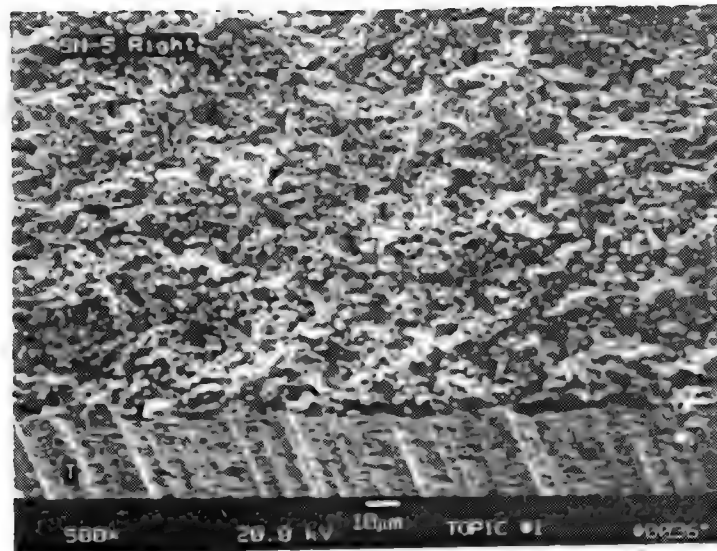
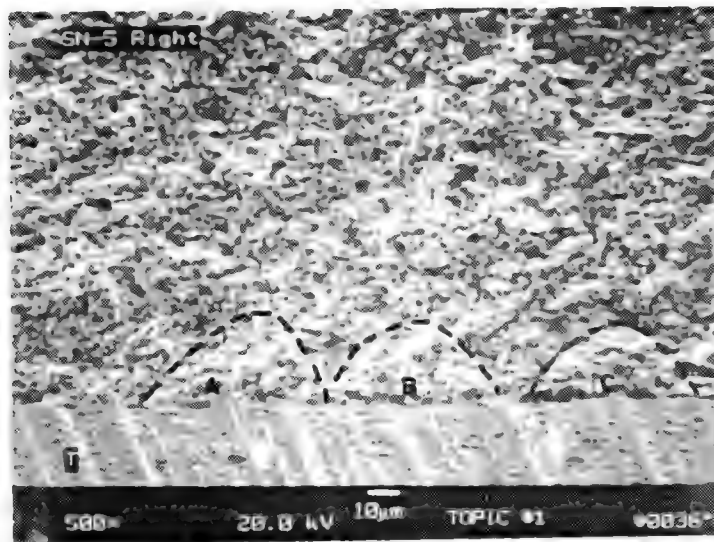
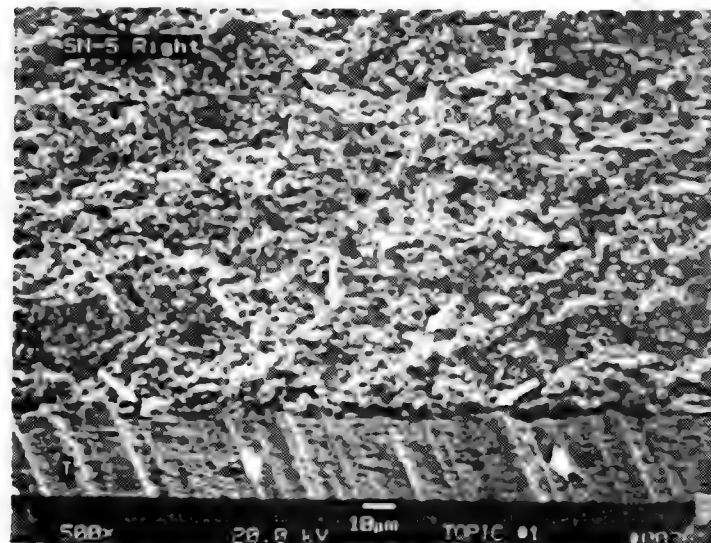
Figure 1.5. High magnification photographs of one half of the fracture surface from Set #2 (SN-5). A) Unmarked. B) The organizers outlined three possible semicircular origins. Arrows indicate possible striations on tensile surface. C) The organizers outlined a possible semielliptical origin. "T" denotes the tensile surface.

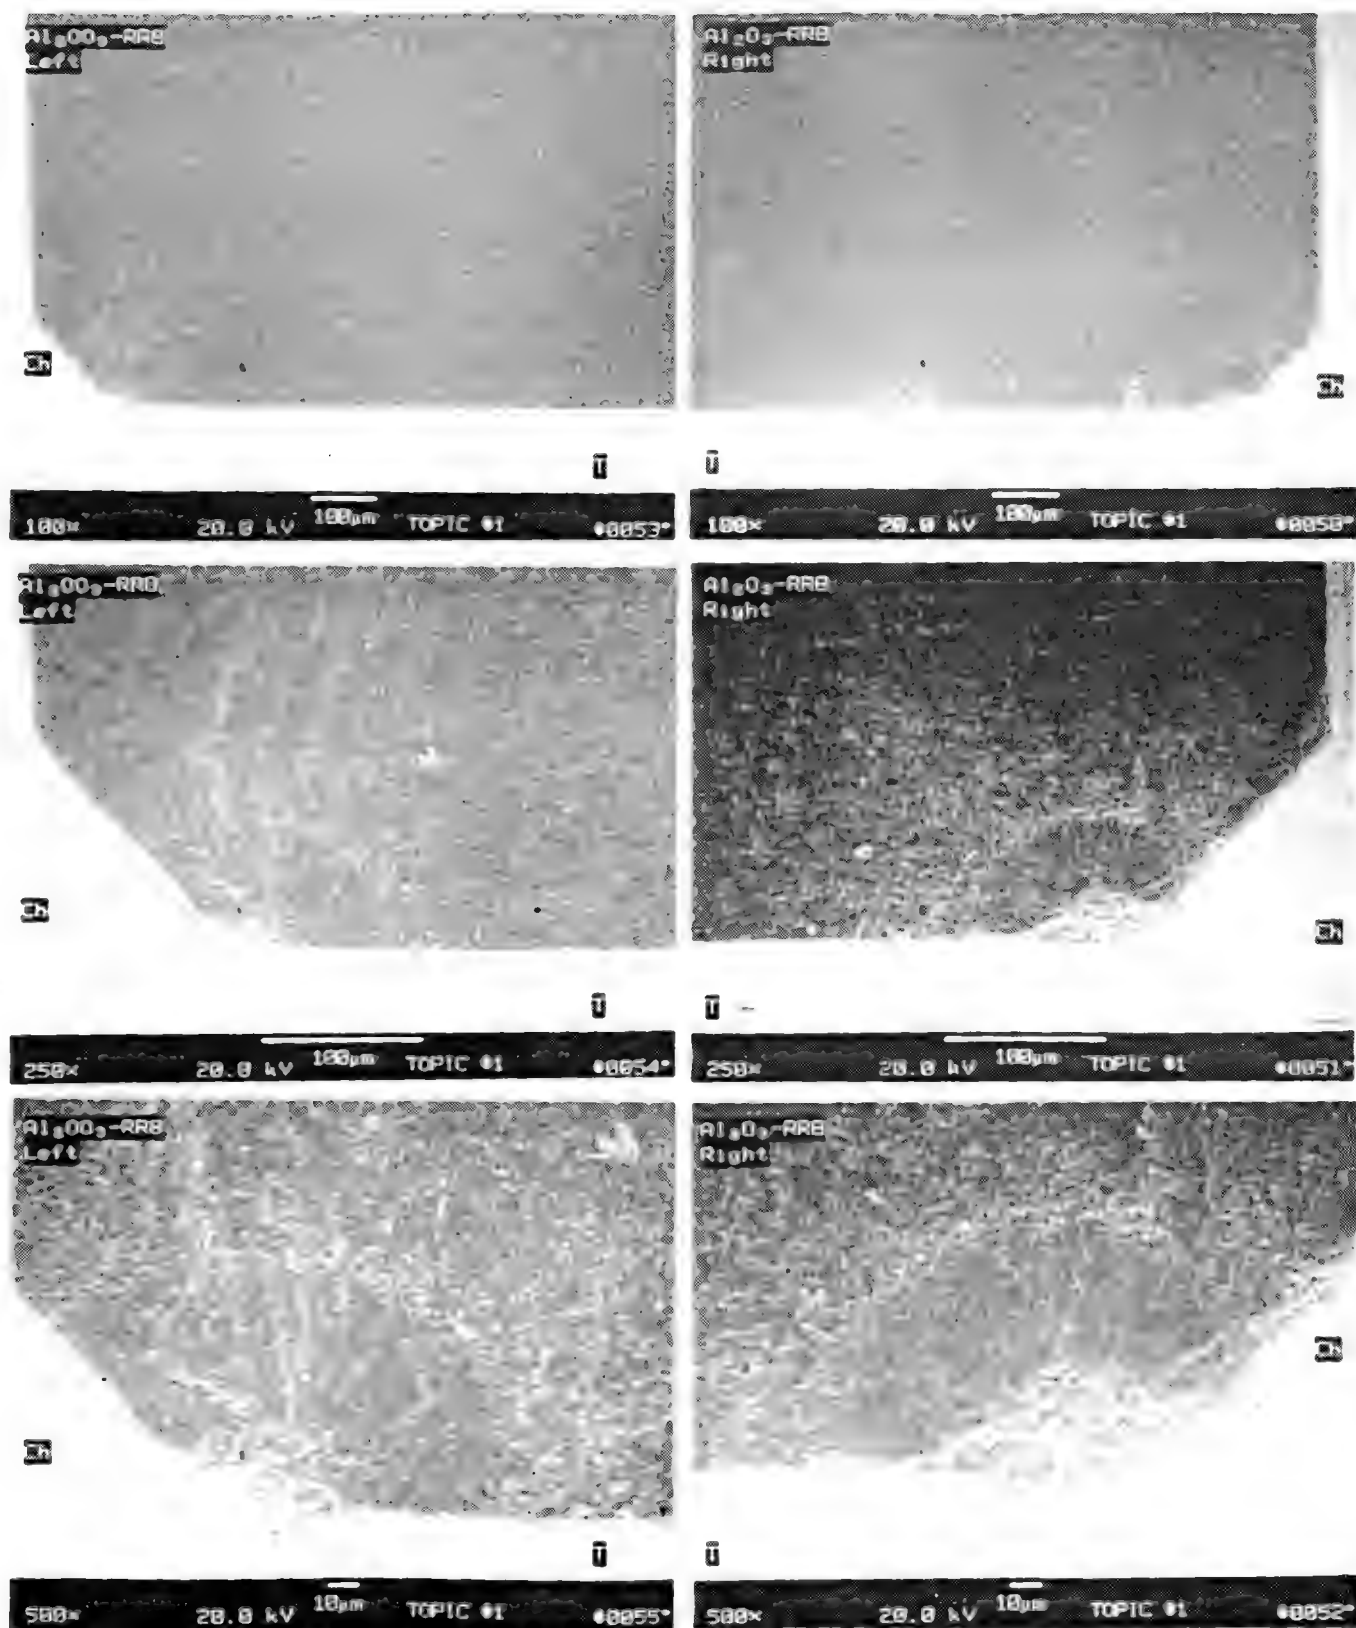
Figure 1.6. The three pairs of photographs for Set #3 ($\text{Al}_2\text{O}_3\text{-RR8}$) which were provided to the participants. "T" denotes the tensile surface and "Ch" the chamfer.

PARTICIPANTS' RESULTS - FRACTURE ORIGIN SIZE IN ALUMINA - The differences in reporting and measuring the origin size continued with this photograph set. Nonetheless, the overall numbers are fairly consistent between participants. Eleven participants reported a single value of 2c, c or depth with the remainder providing a 2-dimensional value. Because the origin is located at or near the edge some participants were unsure as to how to measure it. Some measurements were made across the corner (chamfer), or on a radius running perpendicular from point A, see Figure 1.7B, into the bulk, still others made their measurements from point A along the tensile/fracture surface interface. One participant felt that special instructions should be provided to measure the origin size in such cases.

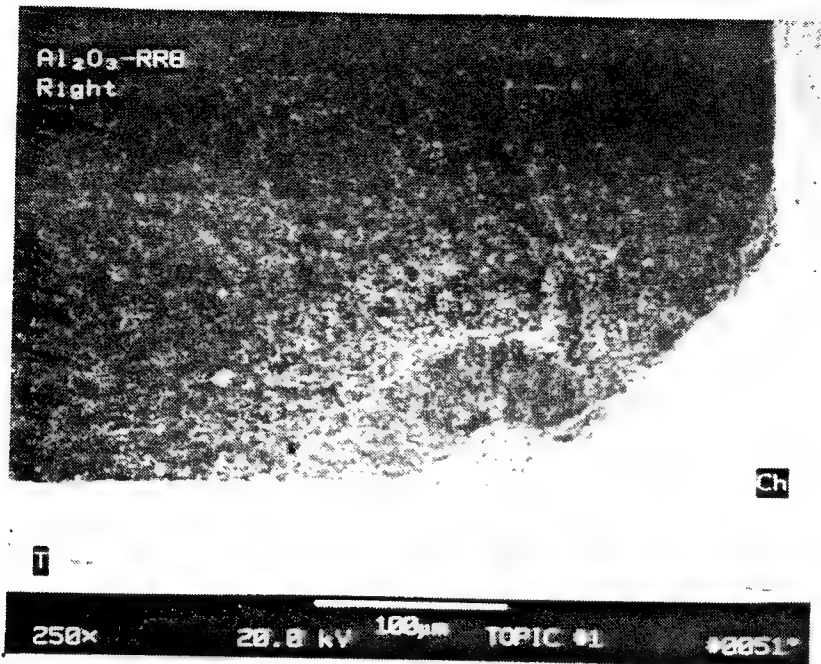
Equation 1b estimates a fracture origin having a size of $c = 182 \mu\text{m}$ ($Y = 1.3$ assuming a semicircular origin at the surface). Two of the four participants (9 & 11) who used fracture mechanics in the previous two sets did so again. Participant 9 used Equation 1a and estimated the toughness to be $2.7 \text{ MPa}\sqrt{\text{m}}$ for $c = 80 \mu\text{m}$ ($Y = 1.3$ from Reference 12). Participant 11 used Equation 1b and was in agreement with the estimated size of the origin. Participant 5 did not indicate the use of fracture mechanics but the radius reported ($c = 120 \mu\text{m}$) is close to the estimated value. Three participants (4, 5 & 11) indicated that these photographs may also show evidence of subcritical crack growth (SCCG).

Figure 1.7. High magnification photographs of one half of the fracture surface from Set #3 (Al₂O₃-RR8). A) Unmarked. B) Three stages of fracture are outlined by the organizers. Stage 1 is transgranular fracture, Stage 2 is subcritical crack growth and Stage 3 is fast fracture. Open arrows indicate the irregular section of the chamfer. "T" denotes the tensile surface and "Ch" the chamfer.

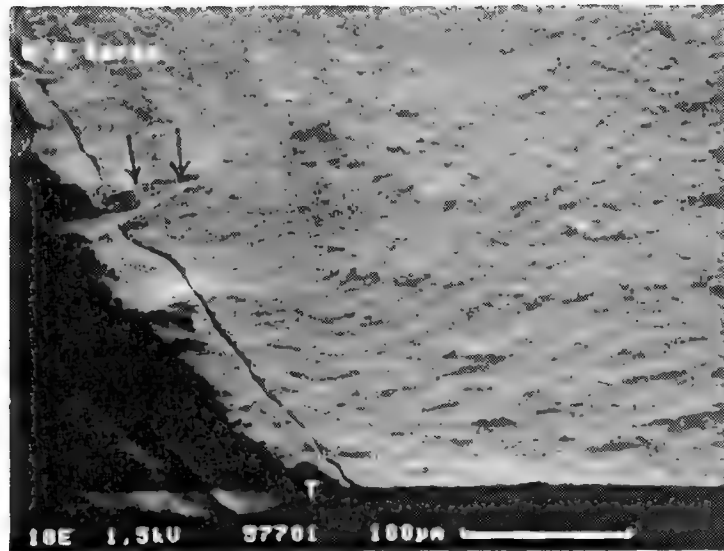
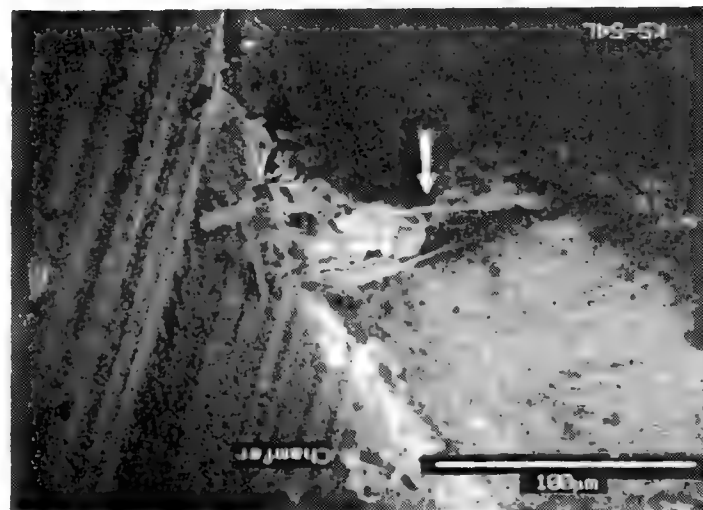
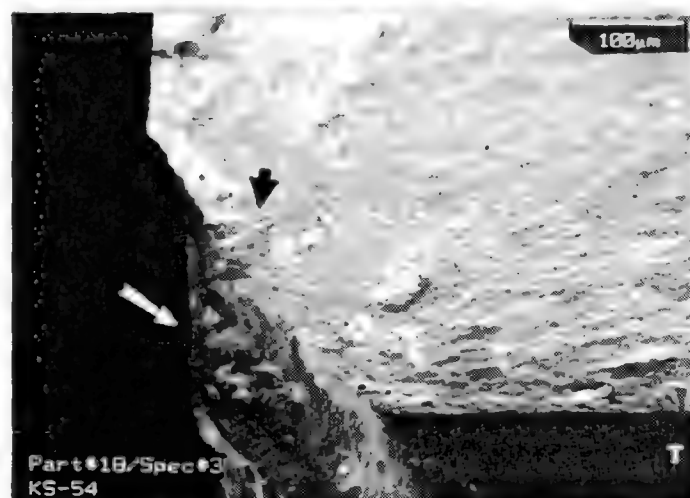
Participant 11 noted the presence of a crack associated with the pore thus the combined label (P/CK), but only one of the primary fracture surfaces was examined with the SEM. Participant 18 also saw a crack in the area of the origin, Figure 2.3.4A, giving rise to the machining damage label, but this crack cannot be seen in any of the organizers' photographs, Figure 2.3.4B, taken prior to the participants' characterization. The organizers reexamined this specimen

Figure 2.3.4. SEM photographs of specimen 3 from the set sent to participant 18. A) Participant 18's photograph. The participant used hand drawn arrows to show the pore. B) SEM photograph taken by the organizers' prior to sending the specimen to the participant. C) Organizers' SEM photograph of the fracture origin after it was characterized by the participant and returned to the organizers. Black arrow indicates the pore and white arrow shows where the piece was removed. "T" denotes the tensile surface.

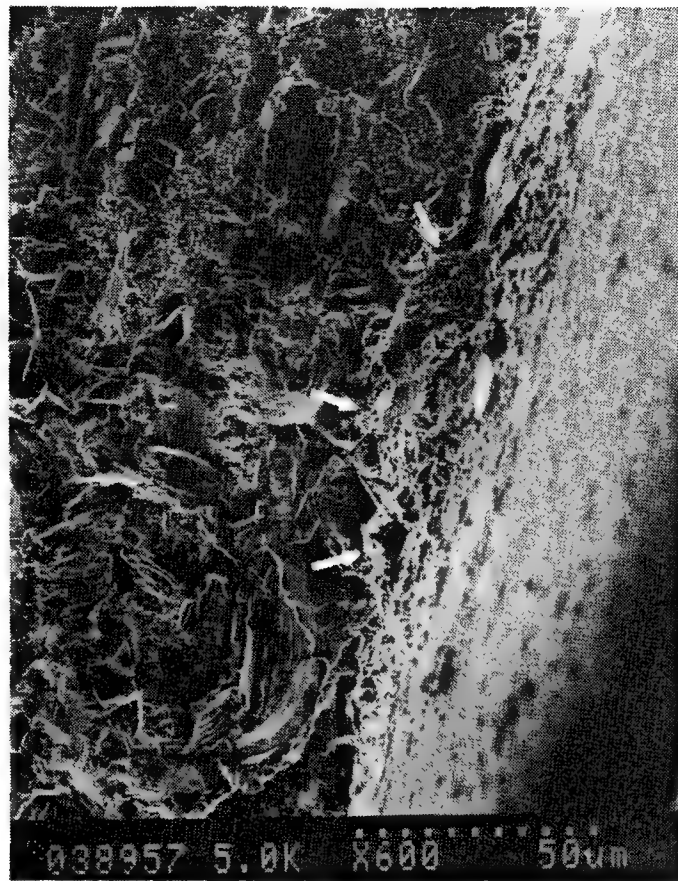
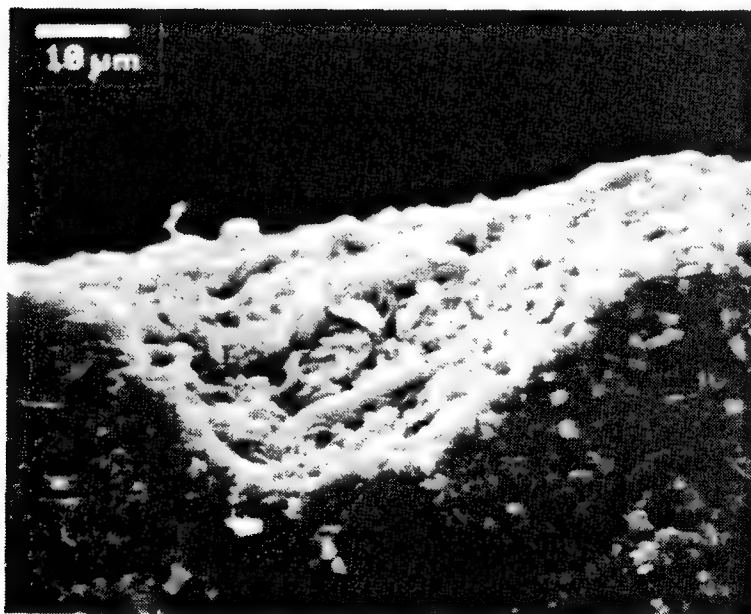
Figure 2.4.2. A) Participant 2's SEM photograph of the pit in specimen 4. Arrows added by the organizers. B) SEM photograph of a surface void from Military Handbook 790, Figure 33, page 40. Note the similarity.

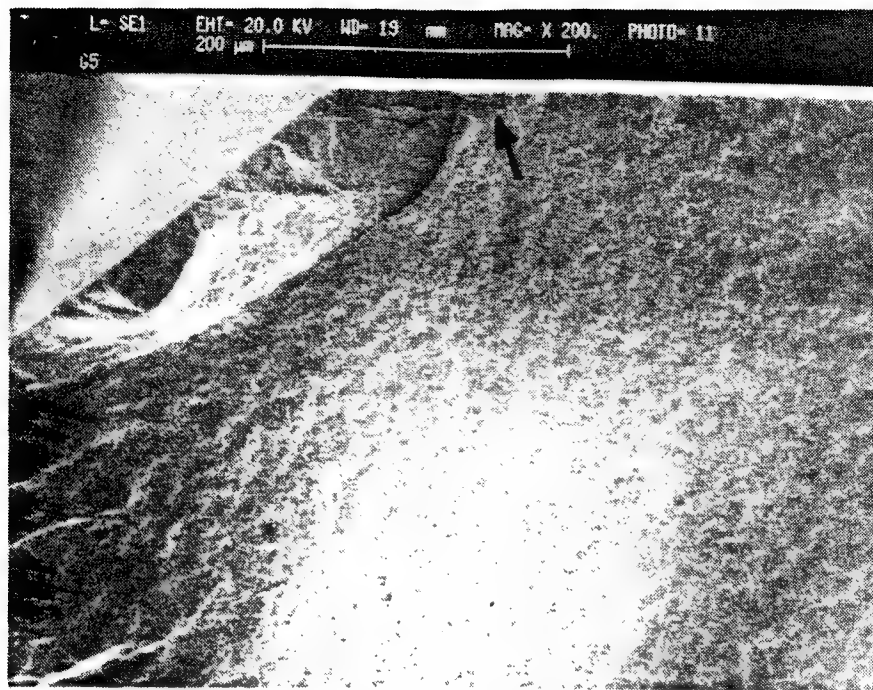
Location - Due to its inherent nature machining damage can only be found at the surface or edge of a ceramic piece. Participants 10, 11 and 18 reported other locations. Participant 10 located it near-to-the-surface but it is clearly located at the surface, Figure 2.5.3. The volume location reported by participant 11 is possible for a "microstructural irregularity", as the origin was labeled. Participant 18 characterized the origin as a coincidental origin of porosity (PR^V) and machining damage with a location of near surface or edge. The near surface label appears to be incorrect for this coincidental origin.

Figure 2.5.3. SEM photographs of specimen 5. A) Participant 10's photograph. B) Organizers' photograph. Arrows point out the machining damage on the tensile surface. "T" denotes the tensile surface.

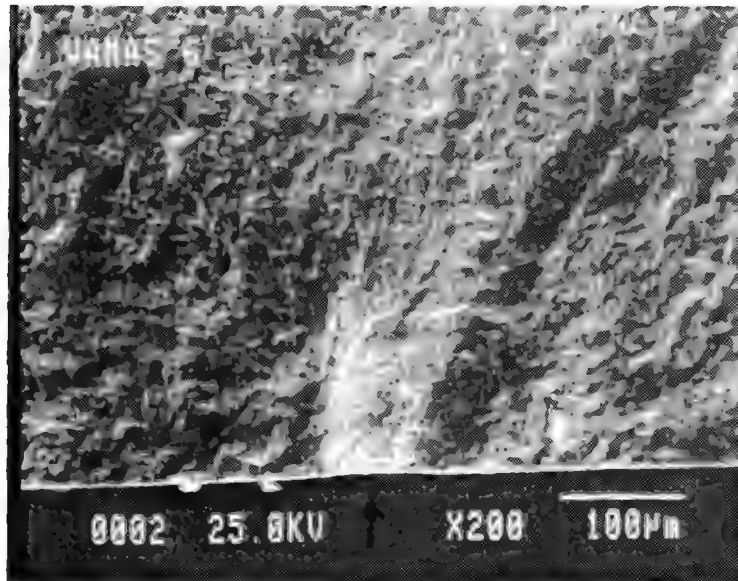
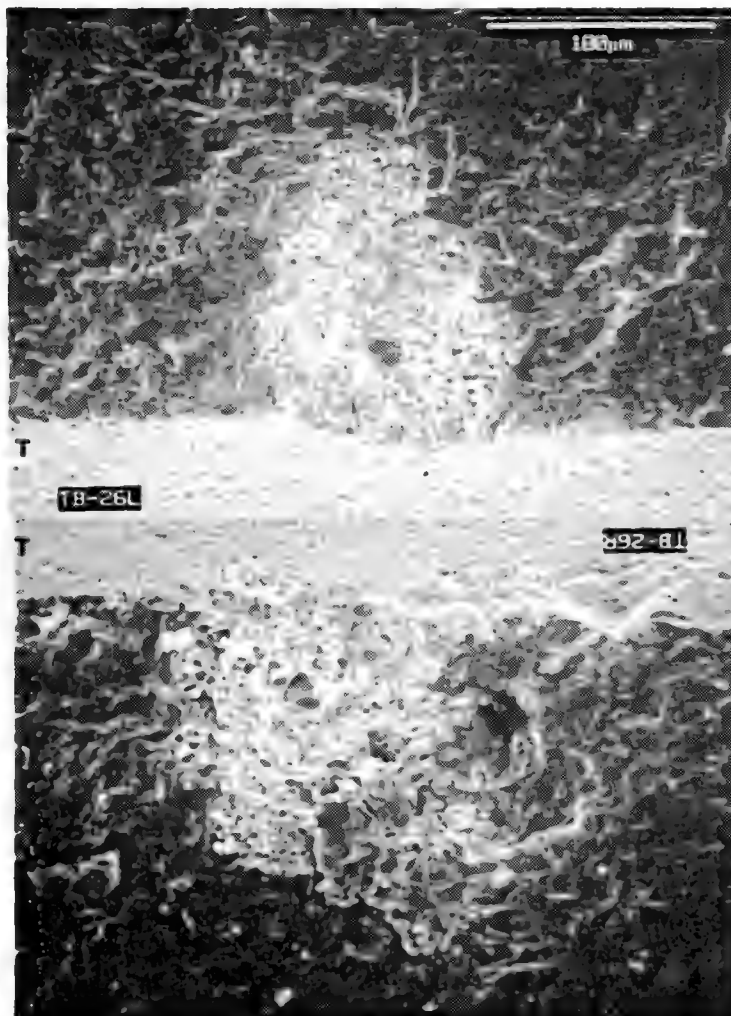
DISCUSSION - Identity - Most participants labeled the origin as porosity related (PV or PR^V) but other labels such as agglomerate (AV), inclusion (IV) and surface void (SV^S) were also given. Five participants (4, 7, 10, 15 and 17) gave the origin an agglomerate label. Their photographs show regions of porosity. This does not fit the definition of agglomerate given in MIL HDBK-790 which states that an agglomerate is a "... solid mass.". Additionally, the organizers believe that if participants 15 and 17 had examined the mating half of the primary fracture surface their identity might have been different. Failure to examine the mating halves of the primary fracture surface can lead to an errant identification of the origin. This is especially true for an agglomerate. Many times one half of the fracture surface will have a depression which is matched on the mating half of the surface by a protrusion of the same size. Figure 2.6.2 shows the mating halves of the fracture surface from participant 15's specimen set.

Figure 2.6.2. SEM photographs of specimen 6. A) Participant 15's photograph. B) Organizers' photographs of the mating halves of the primary fracture surface. The photographs in B) indicate that this origin is a porous region (PR^V) and not an agglomerate (A^V). "T" denotes the tensile surface.

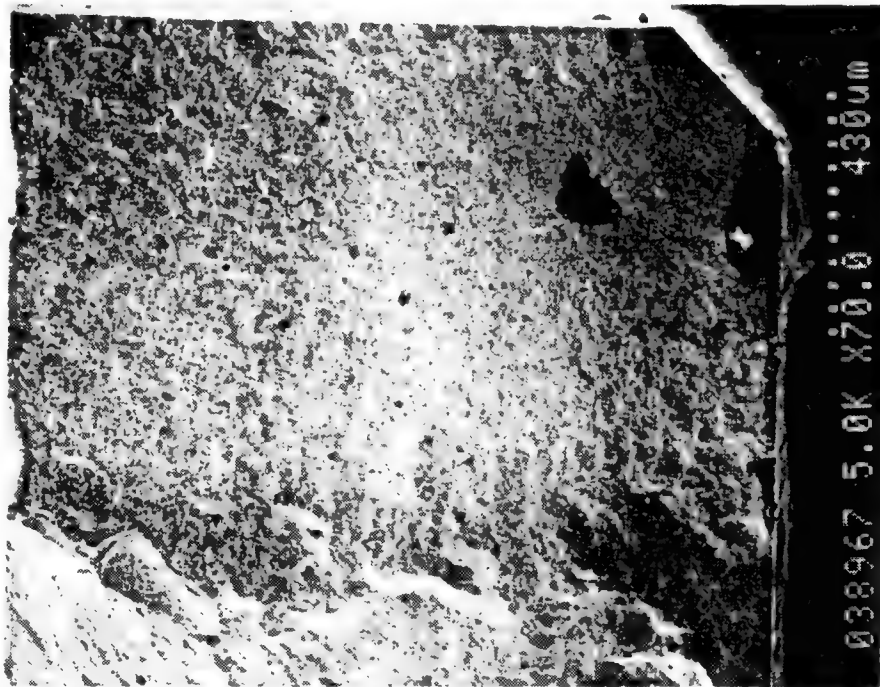
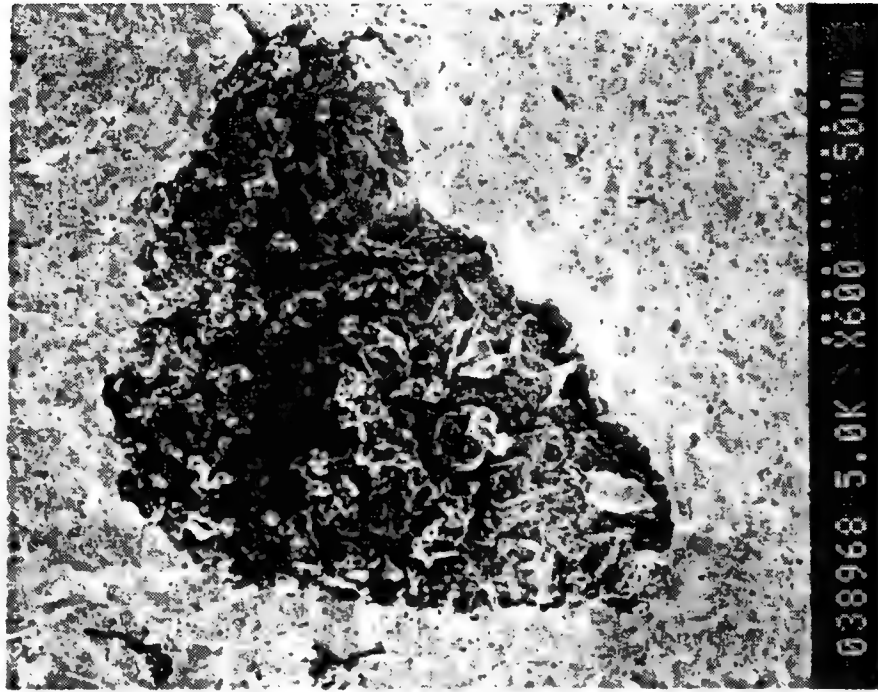
Figure 3.2. Example of the fracture origin, pore (P^v), seen in the β -SiC analyzed by Participant 2. A) 70X. B) 600X.

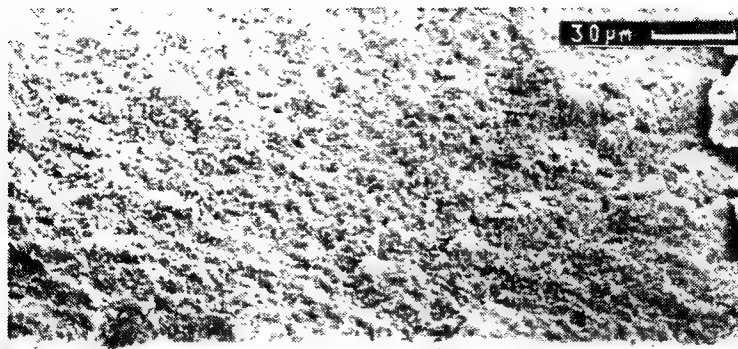
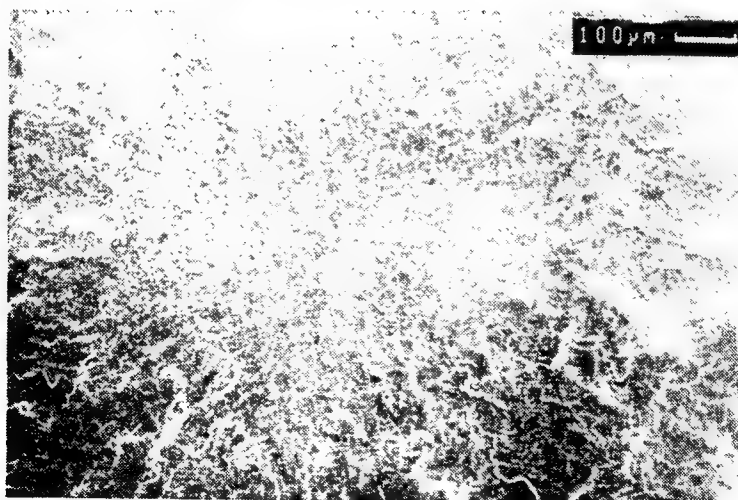
Figure 3.4. Examples of the fracture origins seen in the HIPed Si_3N_4 analyzed by Participant 6. A) Specimen LP-37, Surface at surface? B) Specimen LP-29, Chip located at the edge. C) Specimen LP2-26, Inclusion located in the volume.

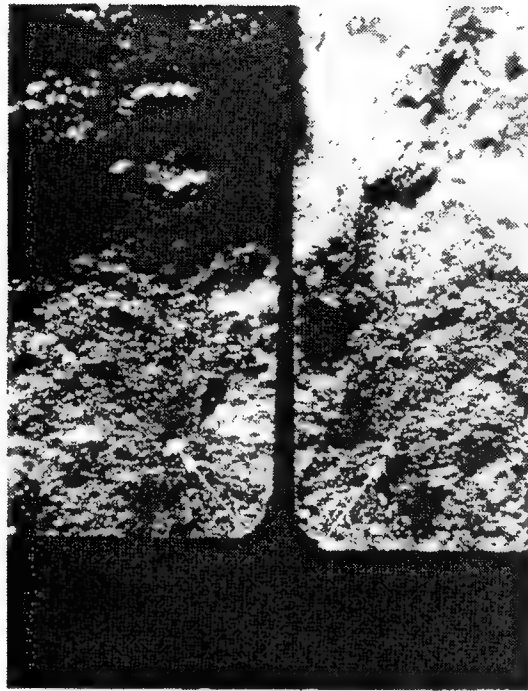
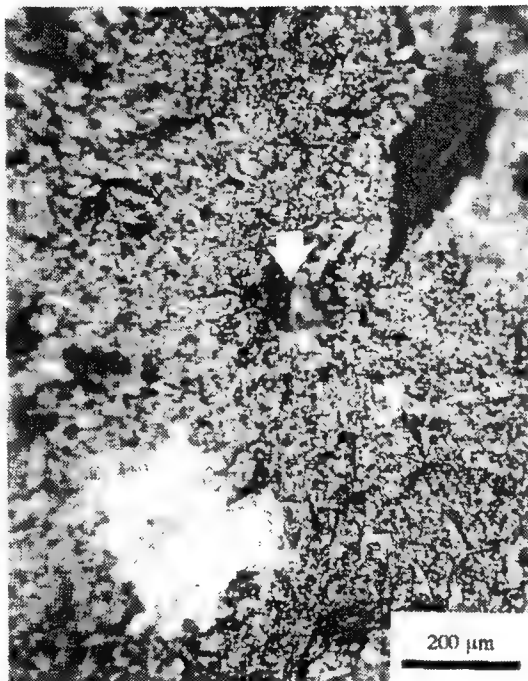
Figure 3.8. Fracture origin in specimen 2 for a $\text{Si}_3\text{N}_4/\text{TiN}$ specimen. Labeled by participant 10 as machining damage.

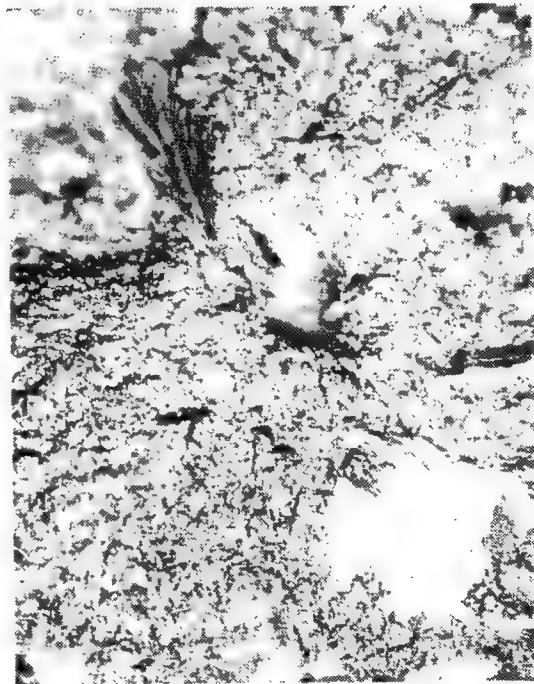
B

The first specimen was a sintered SiC. No processing details were available. The specimen had a fracture stress of 314 MPa. Optical examination of the fracture surface at 25X using grazing incidence illumination revealed that the origin was located near one of the corners, Figure 3.9A. At an optical magnification of 100X using mixed lighting the origin appears to be an agglomerate or an inclusion, Figure 3.9B and C, because there is a raised sphere on one half and a corresponding depression on the mating half. It was noted that even though there are large grains very close to this agglomerate these can not be the origin because river lines pointing to the sphere can clearly be seen in these grains. The origin size was estimated assuming an internal penny-shaped crack, $Y = 1.13$, a fracture toughness of $3 \text{ MPa}\sqrt{\text{m}}$ and a local stress of 180 MPa (This stress took into account the distance the origin was from the tensile surface.). The estimated size (c) is about $218 \mu\text{m}$ which is about twice the reported diameter of the origin.

Figure 3.9. Origins in a sintered-SiC from participant 11. A) Optical photograph taken at 25X using grazing incident illumination. B) and C) Optical photographs of the mating halves of the fracture surface showing the origin. Taken at 100X under mixed lighting. Note large grains with river lines.

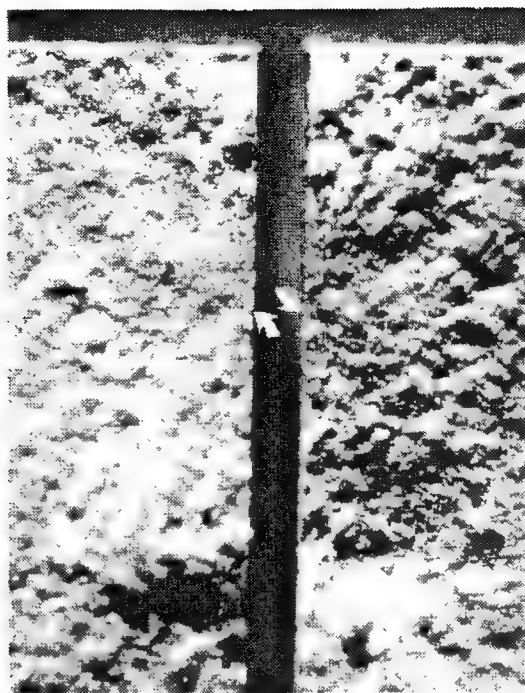
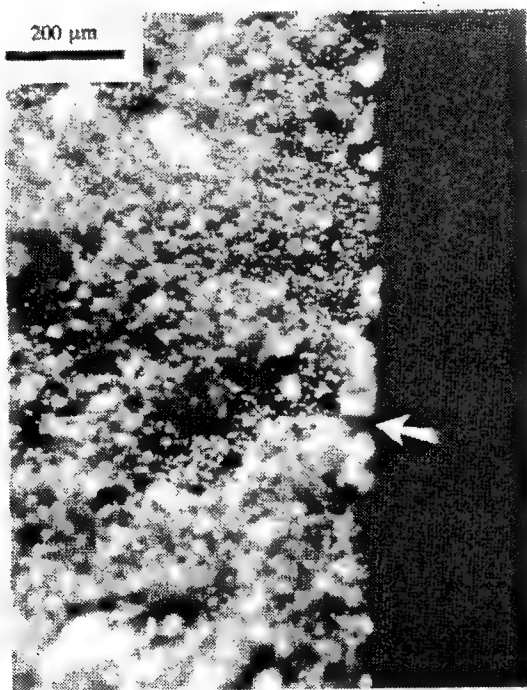
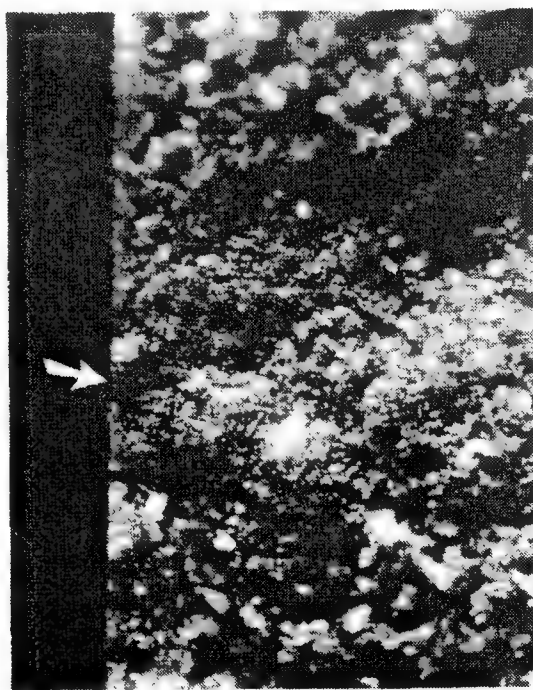
961 and was produced by Morgan Matroc, UK. The alumina grains are typically 3-4 μm with the manganese and titanate phases appearing as sub-micron grains at the alumina grain boundaries. This specimen was machined from die-pressed, fired bars and tested in three-point flexure with a very fast crosshead speed of 5 mm/min. The fracture strength was 366 MPa and the toughness was about 4 MPa $\sqrt{\text{m}}$. The origin is clearly at or close to the surface, Figure 3.10, thus Y was assumed to be 1.4 and the origin size estimated to be about 61 μm . The participant states that there is a "crack-like defect" visible having approximately the right size. The participant further states "It is known that this material is prepared from spray-dried powder, and it is likely that the crack-like defects are elongated pores left by remnants of particles insufficiently crushed in pressing."

Figure 3.10: Origins in an alumina from participant 11. A) Optical photograph of the mating halves of the primary fracture surface, taken at 25X using grazing incident illumination. B) and C) Optical photographs of the mating halves of the fracture surface showing the origin. Taken at 100X under mixed lighting.

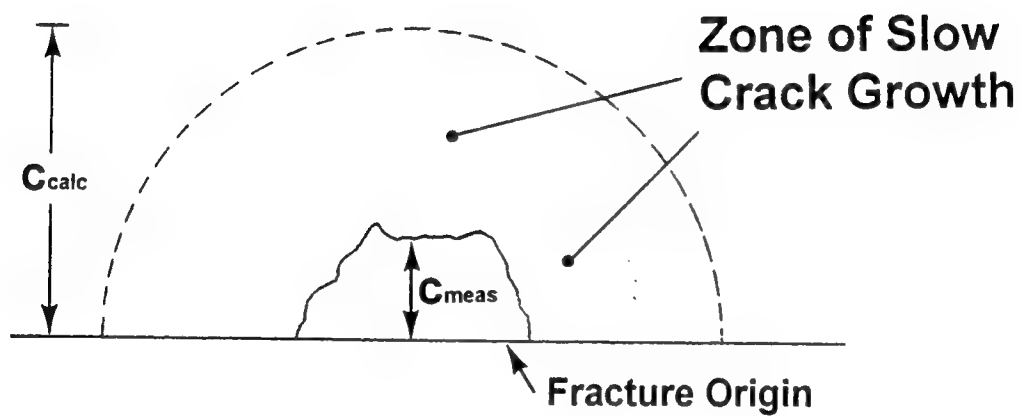
Figure A2.1 Slow crack growth may cause an origin to grow. Fracture occurs when the crack has extended to the critical size which should be the same as the size predicted from fracture mechanics (c_{calc}). If the SCG zone is not detected, then it will appear that c_{calc} is larger than c_{meas} .

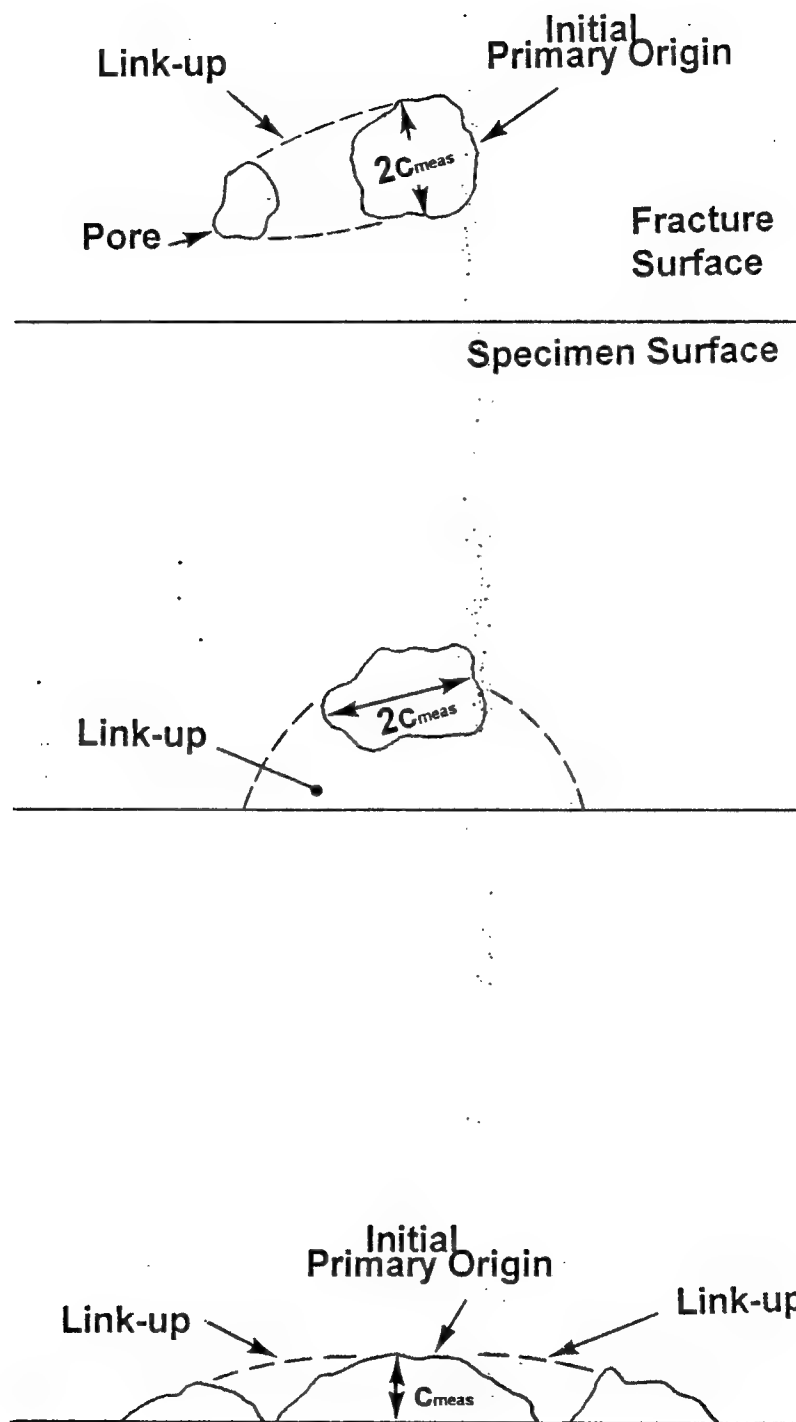
Figure A2.2 A origin can link-up with other discontinuities or with a free surface. The calculated size (c_{calc}) will be larger than the size of the original or initially-obvious origin feature (c_{meas}).

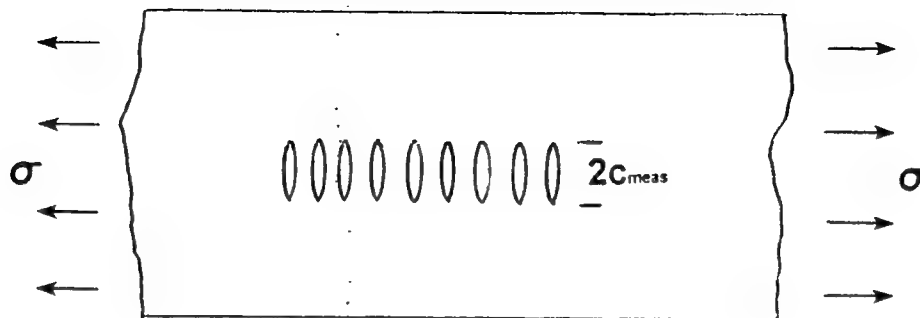
Figure A2.3 Nested, overlapping cracks can lead to a reduction in the stress intensity (Y) at any single crack. In this case c_{calc} will underestimate the crack size measured on the fracture surface (c_{meas}).

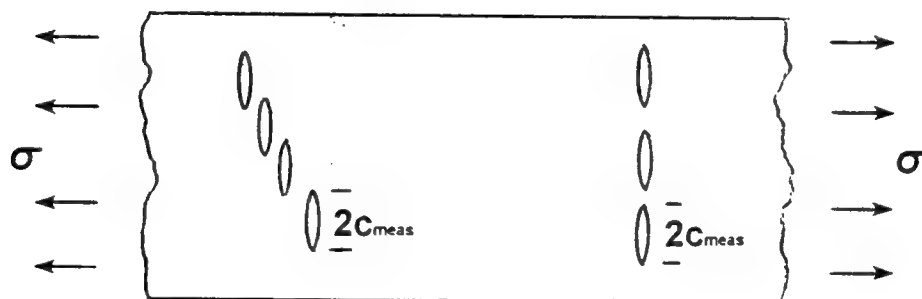
Figure A2.4 Staggered or aligned cracks can cause the stress intensity (Y) to be magnified at the fracture origin. c_{calc} will overestimate the measured crack size (c_{meas}).
